**Flood Control Project Maintenance
Levee Inspections
LMA District Cover Sheet
Spring 2010 Levee Inspection Results**

San Joaquin County Flood Control and Water Conservation District

Spring 2010 Levee Inspection Results

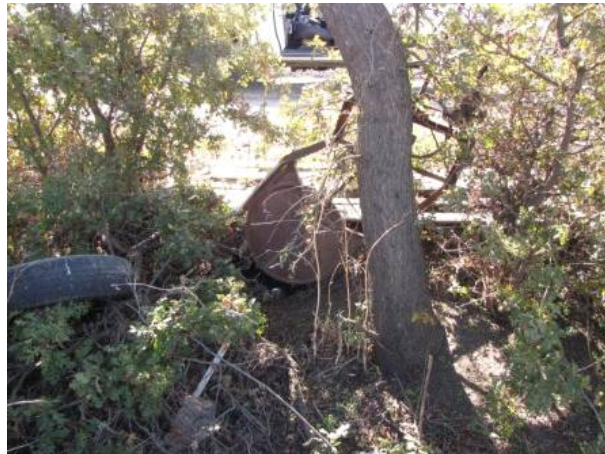
Levee Mile Report Line	10
Start Levee Mile	1.00
End Levee Mile	1.00
Location	Water Side
Category	Earthen Levee
Item	Trim / Thin Trees

View of tree branches blocking visibility and access on the waterward side of the levee looking upstream.

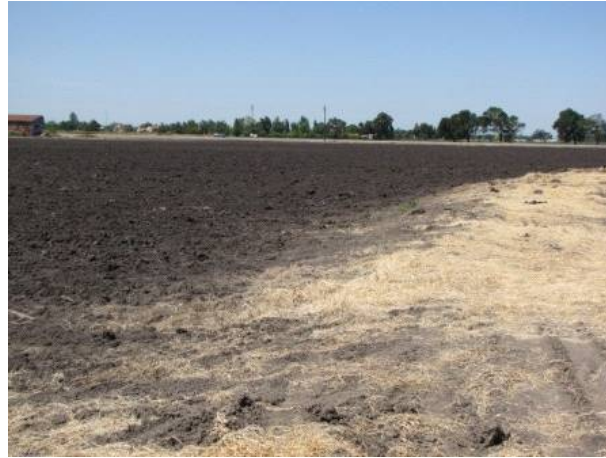
Levee Mile Report Line	15
Start Levee Mile	1.30
End Levee Mile	1.54
Location	Water Side
Category	Earthen Levee
Item	Slope Stability

View of damage to the waterward slope of the levee caused by the landowner driving a tractor over the levee looking downstream.

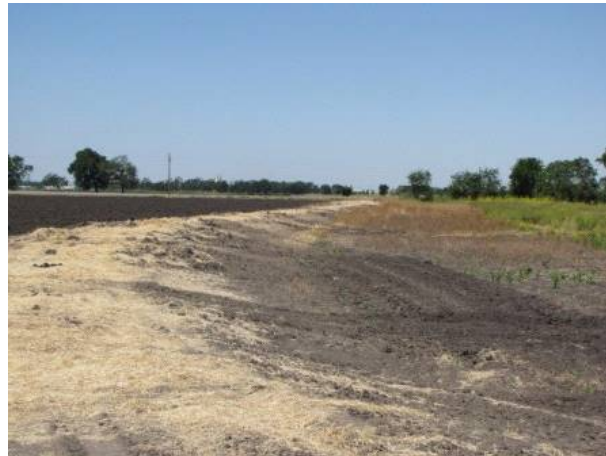
Levee Mile Report Line	16
Start Levee Mile	1.31
End Levee Mile	1.54
Location	Crown
Category	Earthen Levee
Item	Crown Surface / Depressions / Rutting

View of damage to the crown of the levee caused by the landowner driving a tractor over the levee looking downstream.

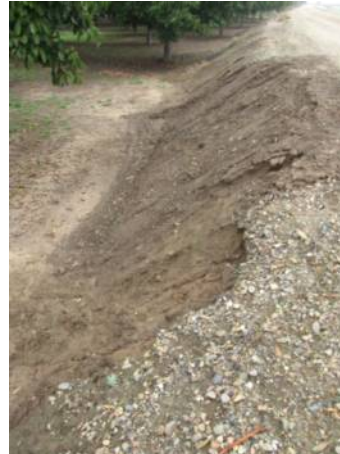
Levee Mile Report Line	87
Start Levee Mile	10.05
End Levee Mile	10.05
Location	Land Side
Category	Earthen Levee
Item	Erosion / Bank Caving

View of erosion occurring on the landward slope.

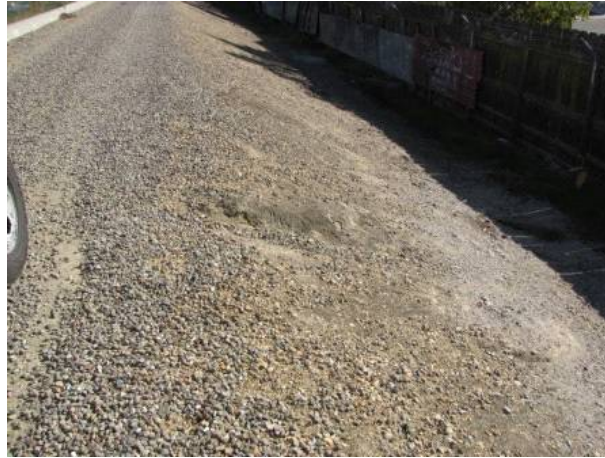
Levee Mile Report Line	52
Start Levee Mile	1.08
End Levee Mile	1.08
Location	Water Side
Category	Earthen Levee
Item	Animal Control

View of a depression likely caused by rodents in the waterward slope looking upstream.

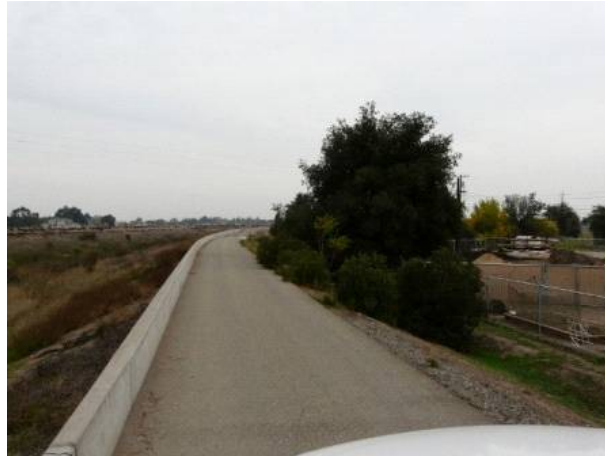
Levee Mile Report Line	149
Start Levee Mile	8.89
End Levee Mile	8.89
Location	Land Side
Category	Earthen Levee
Item	Slope Stability

View of the landward slope damaged by vehicular traffic looking upstream.

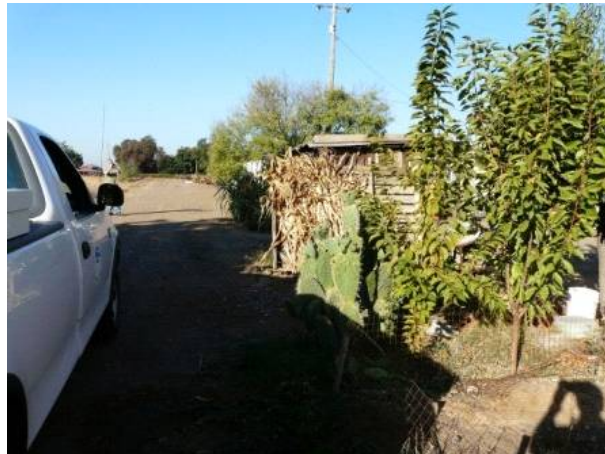
Levee Mile Report Line	93
Start Levee Mile	8.72
End Levee Mile	8.72
Location	Land Side
Category	Earthen Levee
Item	Encroachments
Building, fence and landscaping immediately adjacent to the access road at LM 8.72.	
dpesaven_s_20100316_268.JPG

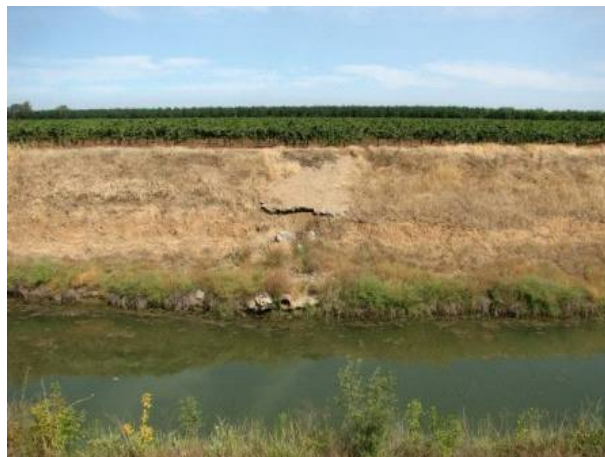
Levee Mile Report Line	98
Start Levee Mile	9.10
End Levee Mile	9.12
Location	Water Side
Category	Supplemental
Item	DWR Erosion Survey
2009: Erosion is incising into the levee; a pipe outlet is located at the levee toe; there are traces of concrete lining originally placed over the slope; levee is on high ground; inspect for potential pipe leak [2009 SiteID:NA0017U15RM9.11]	
SJR2009_LM9.11U15A 081209A.JPG
